Manhole Inspection Summary

Manhole # S29AA2003MH

Inspection ☐ Is Incomplete Rating: **4) Poor**

Location Address: **106 NORTHERN PKWY**

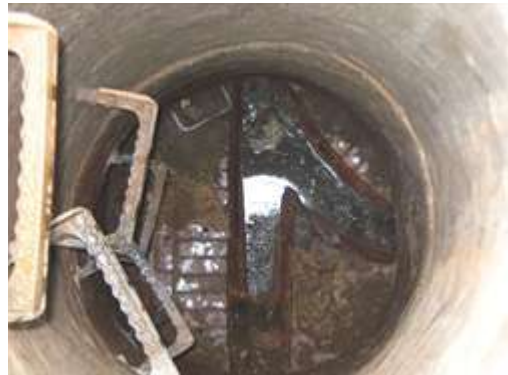
Top View

☒ **Debris** (not Condition related)

Condition: ☐ Sound ☐ Cracked ☐ Root Intrusion ☒ **Deteriorated** ☐ Leaks ☒ **Debris**

☒ **Evidence Of Surcharge**

Depth: **1.5** (ft.)

Evidence of surcharge - Bench debris.
Channel debris.

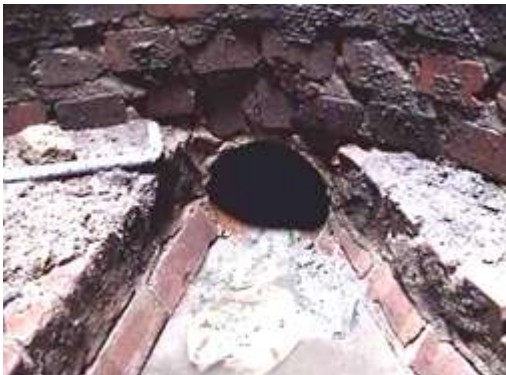
Defect

Condition: ☐ Sound ☐ Cracked ☐ Root Intrusion ☐ Loose Brick ☒ **Deteriorated**

Infiltration: ☐ None ☐ Joint ☐ Cracks ☒ **Mortar** ☐ Roots ☒ **Wall**

Barrel deterioration and infiltration.
Channel deterioration.

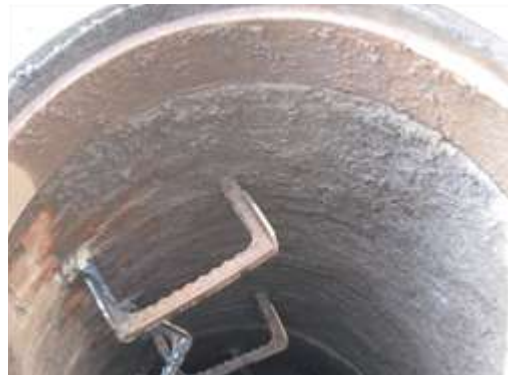
Defect

☒ **Leaks**

Infiltration: ☐ None ☒ **Joint** ☐ Cracks ☐ Mortar ☐ Roots ☒ **Wall**

Infiltration: ☐ None ☐ Joint ☐ Cracks ☐ Mortar ☐ Roots ☒ **Wall**

Frame leaks. Adjustment and Corbel
infiltration.

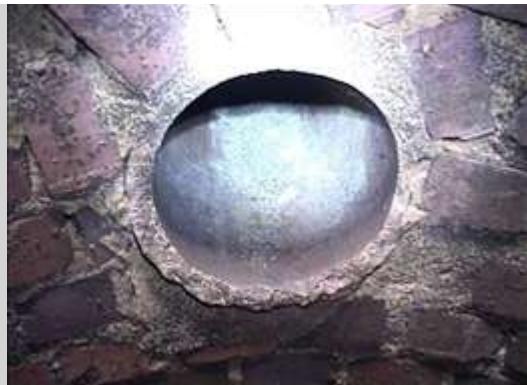
8 in. Circular Gravity Sewer Pipe In @ 3 O'Clock

Infiltration: **Evidence** Pipe Seal Cond: **Unknown**
